Accu-Glass Products Inc.
 25047 Anza Drive
 Valencia, CA 91355
 T 818-365-4215
 F 818-365-7074
 www.accuglassproducts.com

Title PBD-275			
Drawn by Date	CR 3/25/2009	No. 112071	Rev. B
Approved	C M	Sheet 1 OF 1

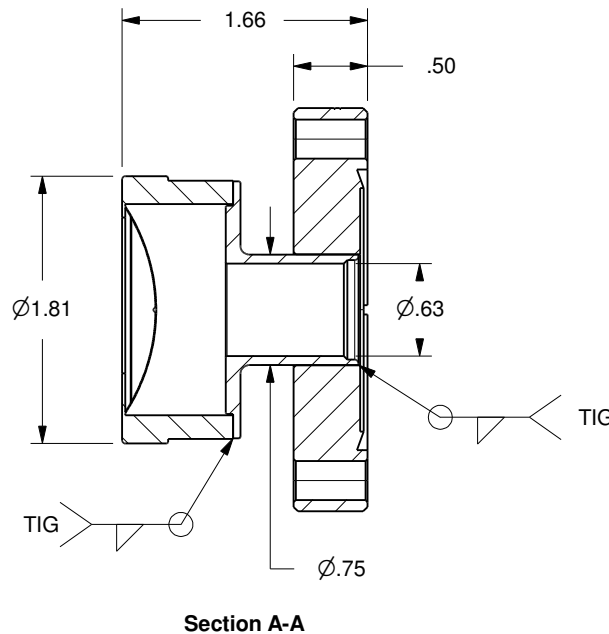
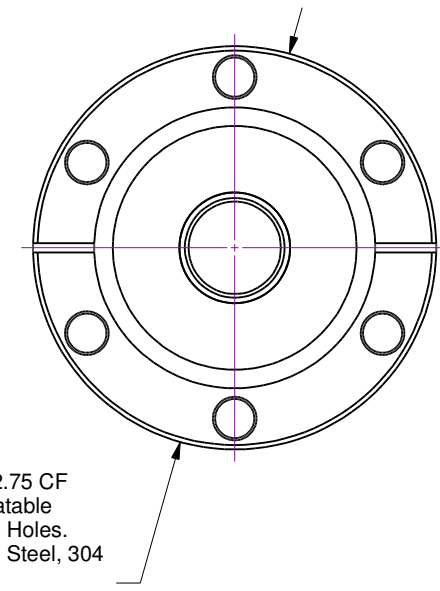
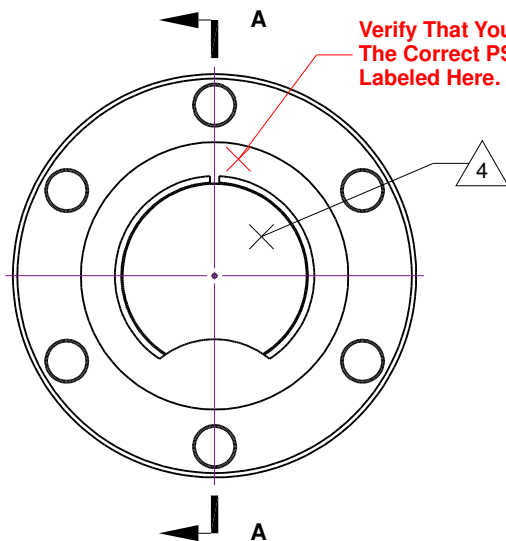
- 1. Leak Tested To 5x10E-10 standard cc/se of He.
- 2. Dimensions Symmetrical About Centerlines.
- 3. This is a vacuum safety 'over pressurization prevention' device. As such, ruptured discs can not be repaired, and must be replaced with a completely new unit.
- 4. Be Careful Of Burst Disc Foil, It Is Very Fragile
