- 1. Leak Tested To 5x10E-10 standard cc/se of He.
- 2. Dimensions Symmetrical About Centerlines.
- 3. This is a vacuum safety 'over pressurization prevention' device. As such, ruptured discs can not be repaired, and must be replaced with a completely new unit.
- 4. Be Careful Of Burst Disc Foil, It Is Very Fragile

Title PBD-K16			
Drawn by Date	CR 3/25/2009	No. 112072	Rev. B
Approved	C M	Sheet	1 OF 1

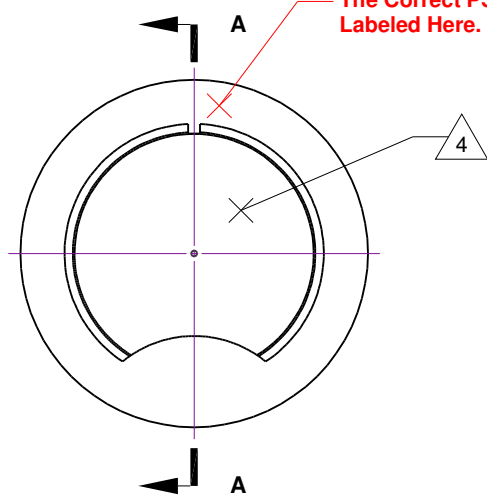
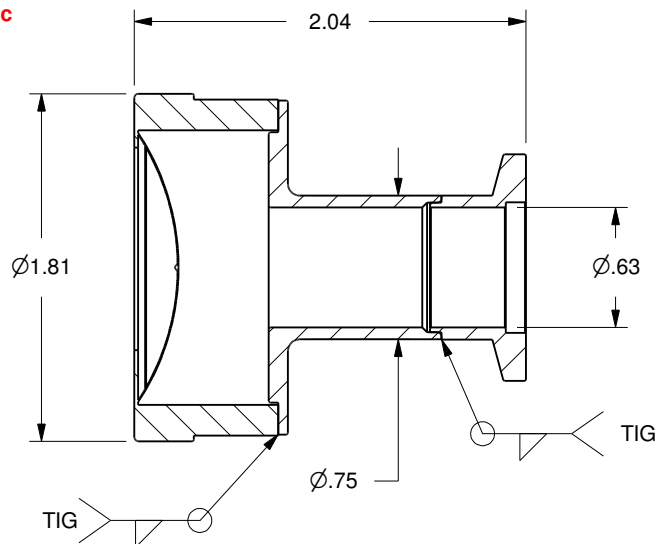
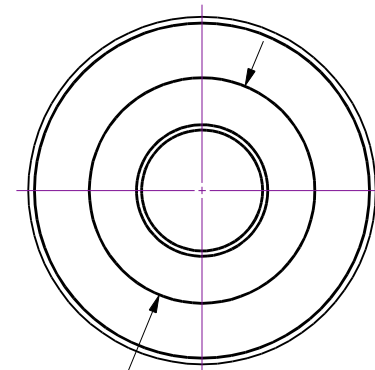
Section A-A

Verify That You have
The Correct PSI Burst Disc
Labeled Here. 15 - 25 PSI

Flange, NW16 KF
Non-Rotatable
with Thru Holes.
Stainless Steel, 304
Ø1.18
